Recent FE-B Module Experience at LBL

K. Einsweiler, LBNL

Status and results from first two FE-B modules

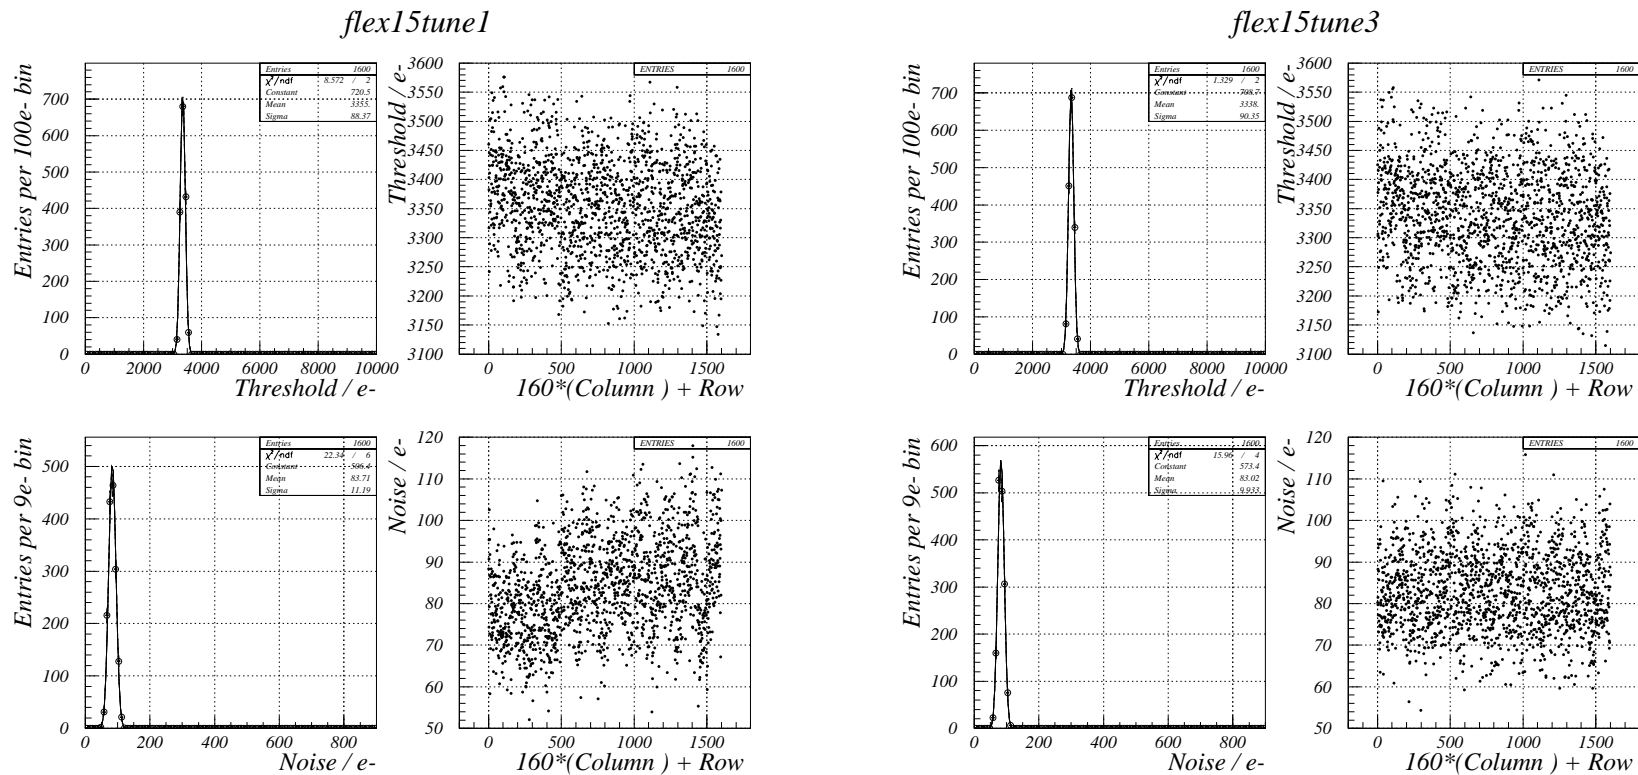
- An example of a different chip which shows stable low noise behavior:

- One lesson from this: in the single chip cards, the chips were always attached with conducting epoxy, whereas in the modules, we used Dow340 plus UV-cure epoxy (insulating). For the Flex, we used conducting epoxy, and it still shows qualitatively similar noise effects to the full module. Probably the substrate contact method is not the problem...
